**INVESTIGATION OF PAVEMENT CRACKING ON SR-4 AND  
DEMONSTRATION OF THE MULTI-HEAD BREAKER  
IN FRACTURING REINFORCED CONCRETE PAVEMENTS  
BEFORE ASPHALT OVERLAY**

Final Report

State Job Number 134196

May 2006

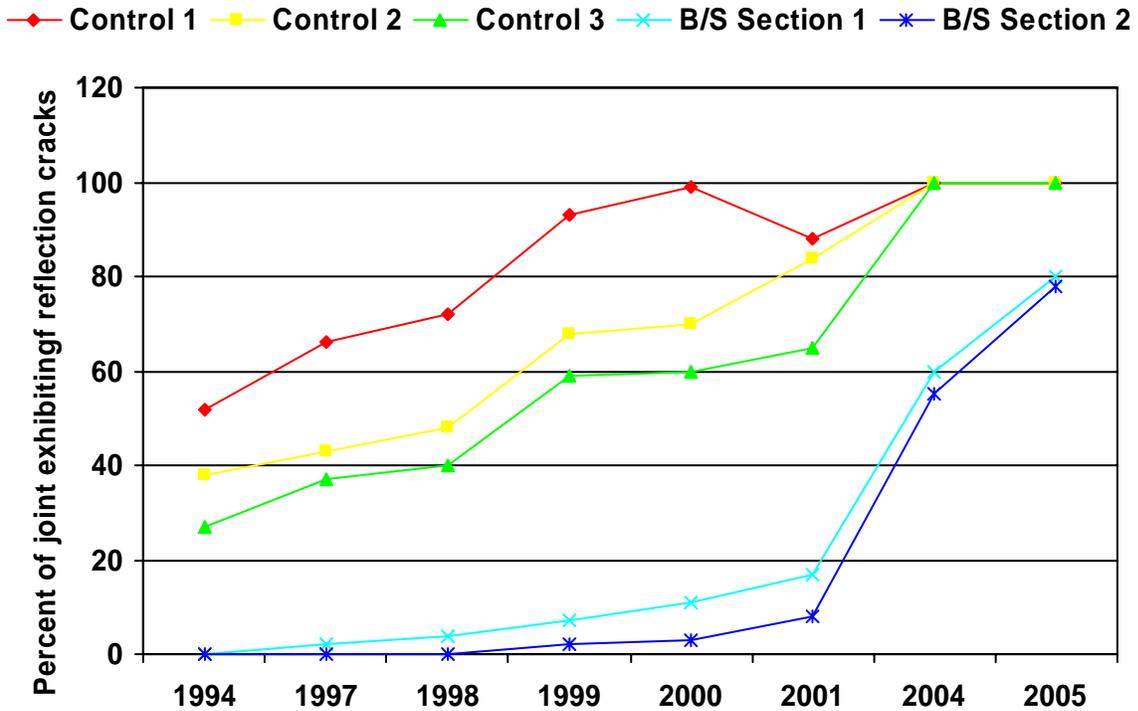
**Figure 5. Progression of Reflection Cracking on SR-4**

Thus, after 10+ years of service, it seems that the slab action has been restored in the underlying concrete due to (a) insufficient fracturing and/or steel debonding during construction or (b) closure of the initial fractures by some in-service slab-stiffening mechanism.

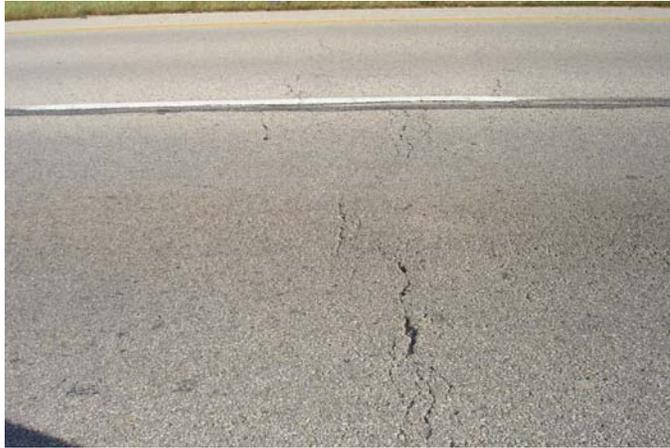
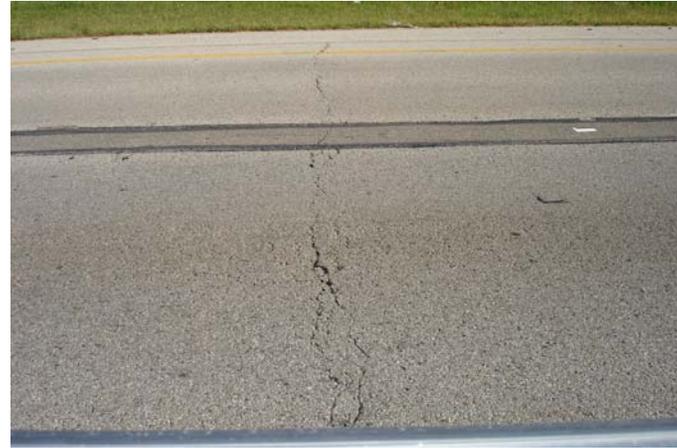
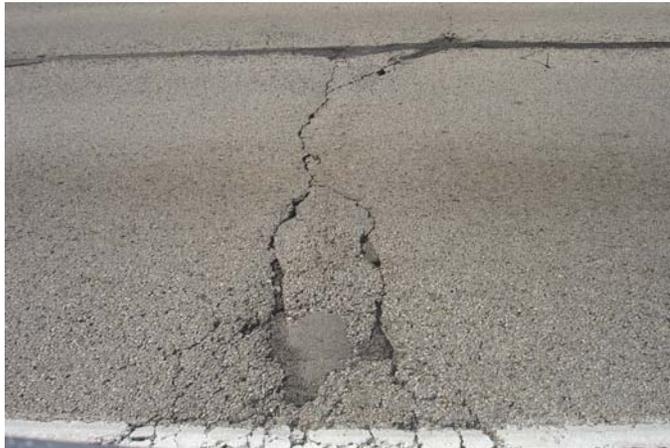
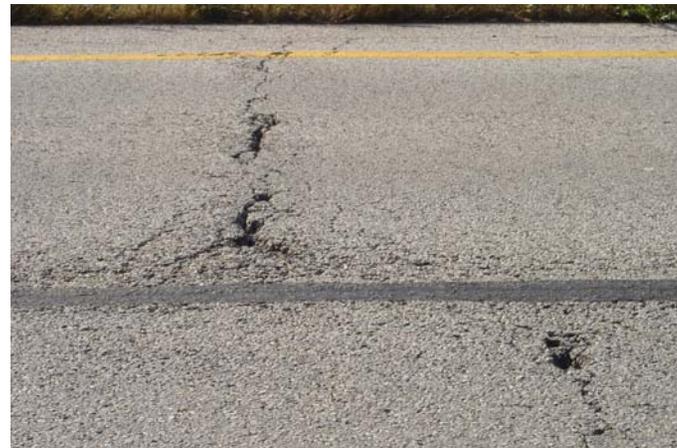
**Figure 6. Appearance of SR-4, Station 105-160, October 2005**

Photos of typical joint reflection cracks in the test and control sections in late 2005 are presented in Figures 6 and 7. As shown, the cracking on the B/S sections is generally less pronounced than on the companion control sites, and consists mostly of single-line cracks. In contrast, the reflection cracking and related distress on the control sites is significantly more severe. Many of the cracks are in the final stages of a well-known pattern: single-line cracks that have progressed to double-line cracks, with spalling of the pavement material between the two cracks.

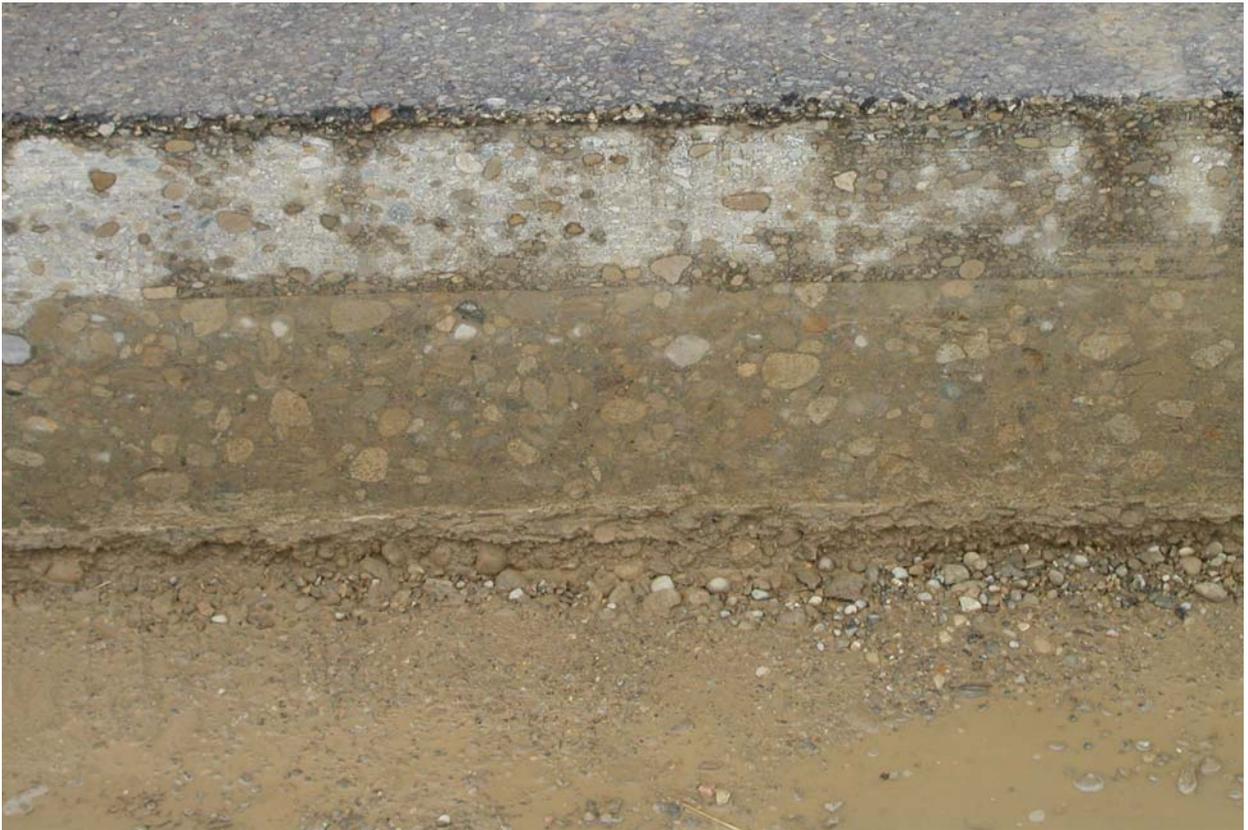
no signs of fracturing whatsoever (Figure 11, 12). As noted earlier, according to the project specifications, the maximum permissible particle size was 30” and the target size was 18”. Further, in many cases, the cracking produced was not near-vertical *through* cracking of the slab that was expected and desired, but rather consisted of mostly horizontal, shallow fracture planes (Figures 12-15).

**Figure 11. Exposed Slab Showing No Fracture**

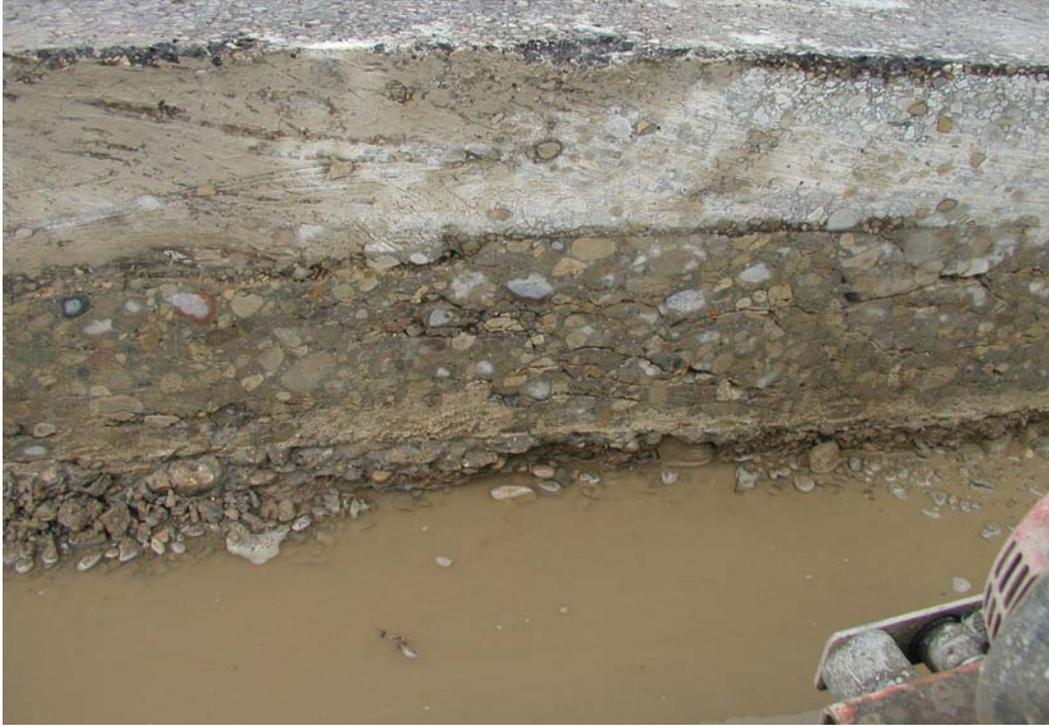
**Figure 12. Horizontal, Shallow Fractured Plane**

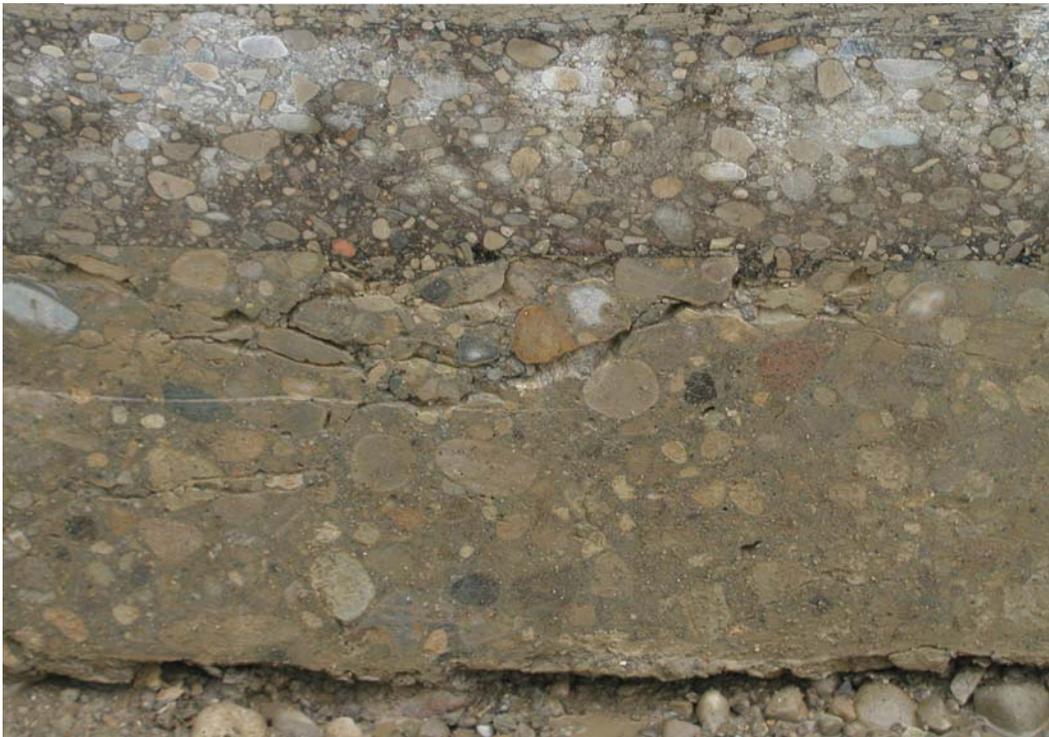
**Figure 13. Horizontal, Shallow Fractured Plane**

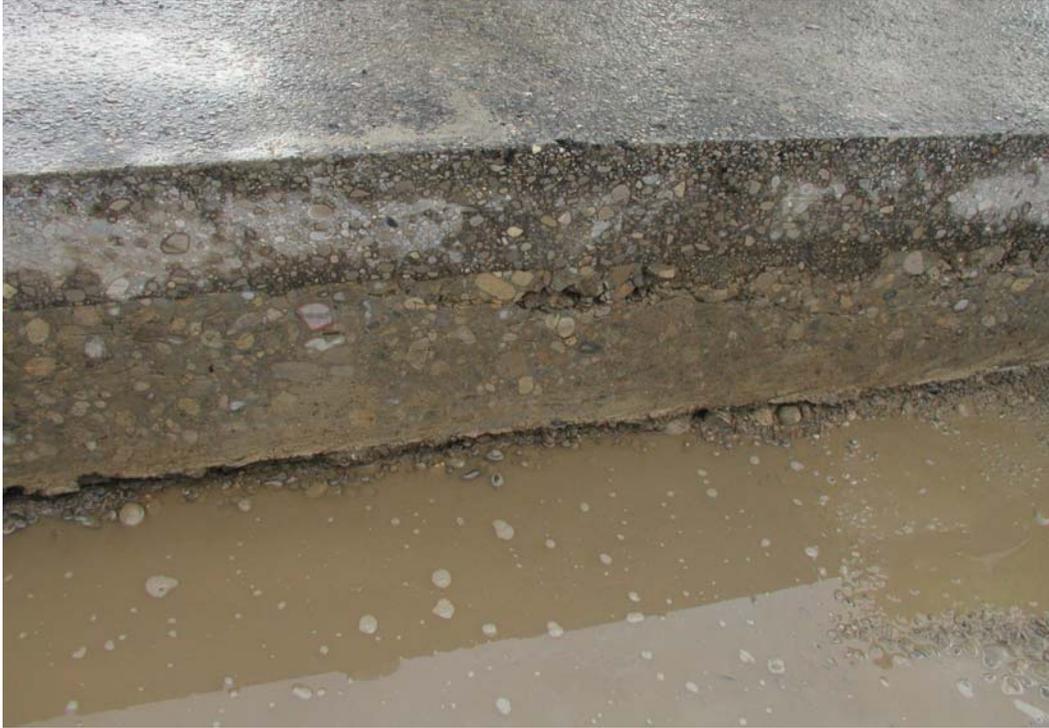
**Figure 14. Horizontal, Shallow Fractured Plane**

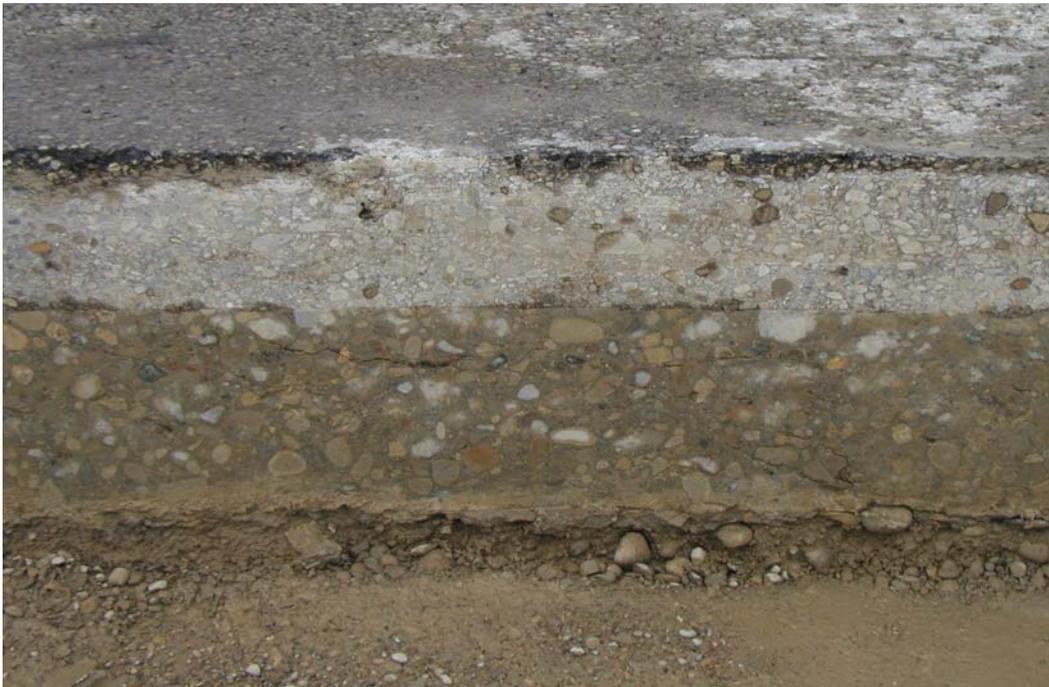
**Figure 15. Horizontal, Shallow Fractured Plane**

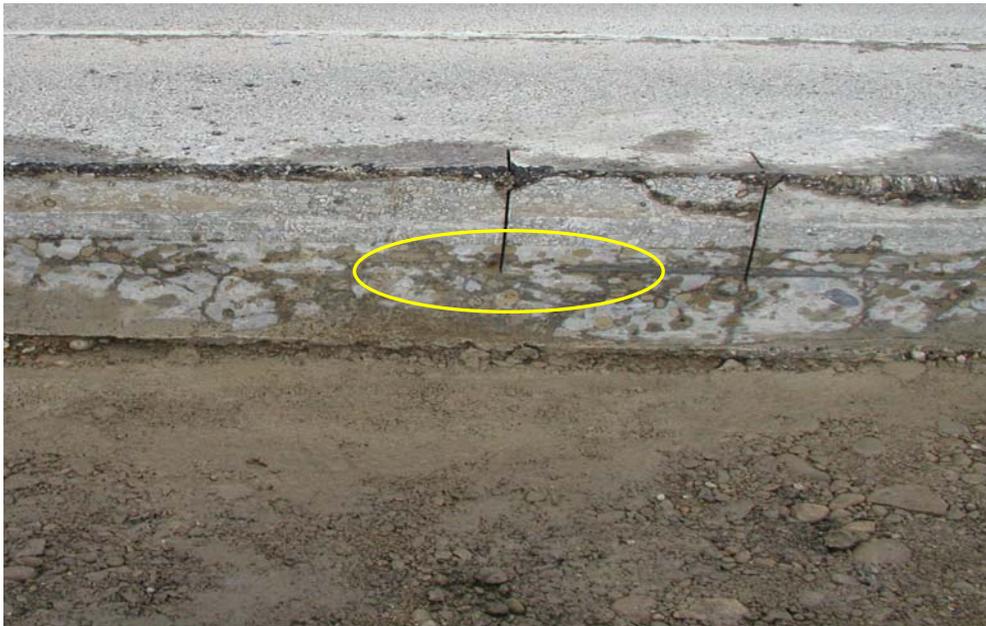
In those sections of the concrete slab where the reinforcing steel was exposed and could be examined, it was apparent that the pile hammer had generally not succeeded in breaking the bond between the steel and concrete (Figure 16).

**Figure 16. Condition of Reinforcing Steel**

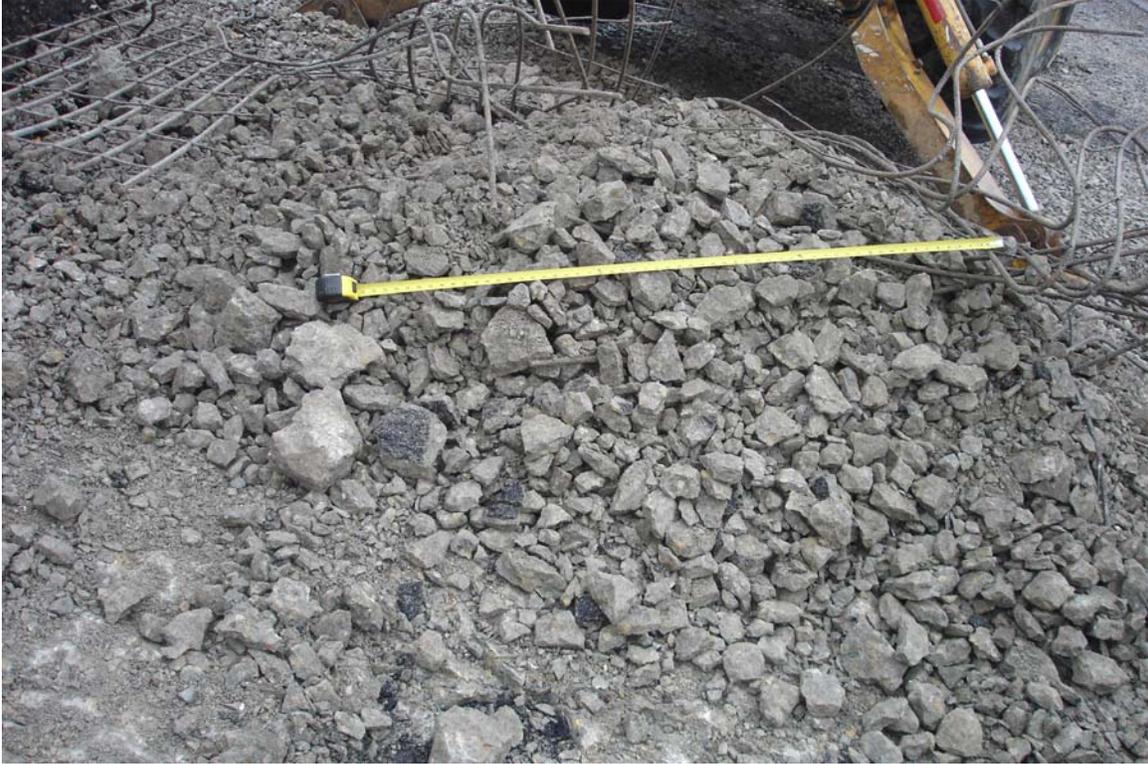
27-32). This was generally not the case on the I-70 project; there, the initial visual inspection of the excavated concrete revealed relatively few overly large pieces (Figures 33, 34).

**Figure 33. Appearance of Excavated Concrete on I-70 Project**

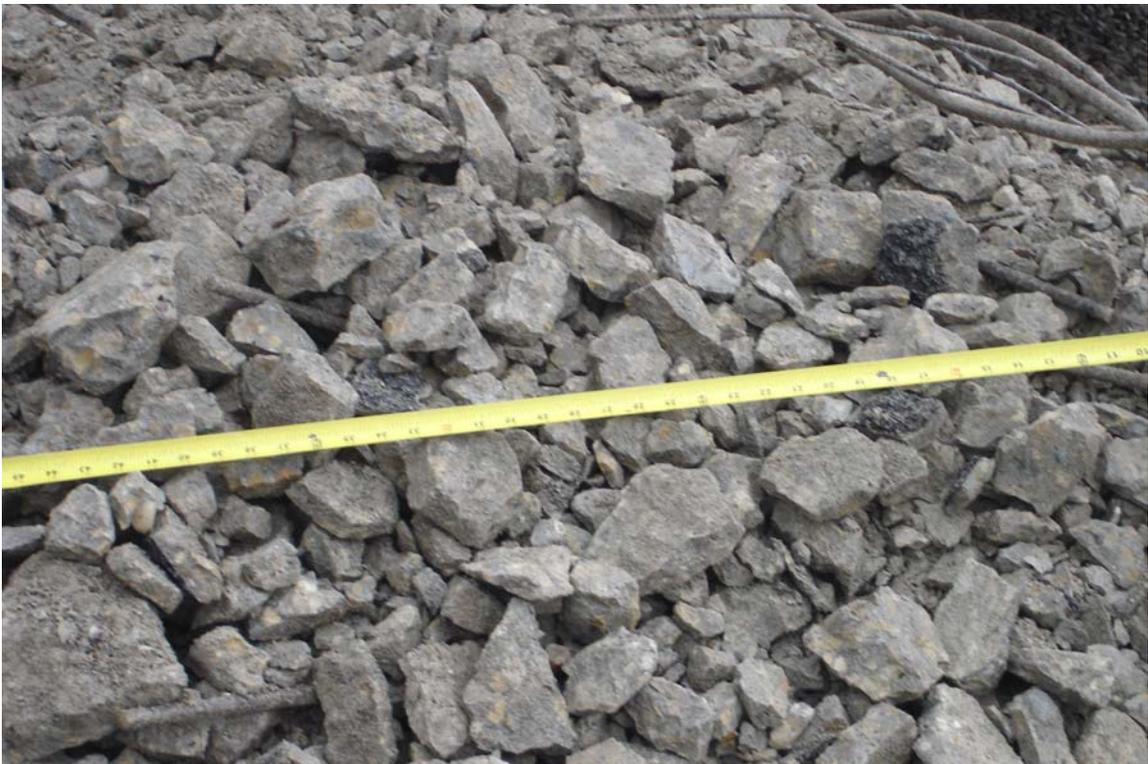
**Figure 34. Appearance of Excavated Concrete on I-70 Project**

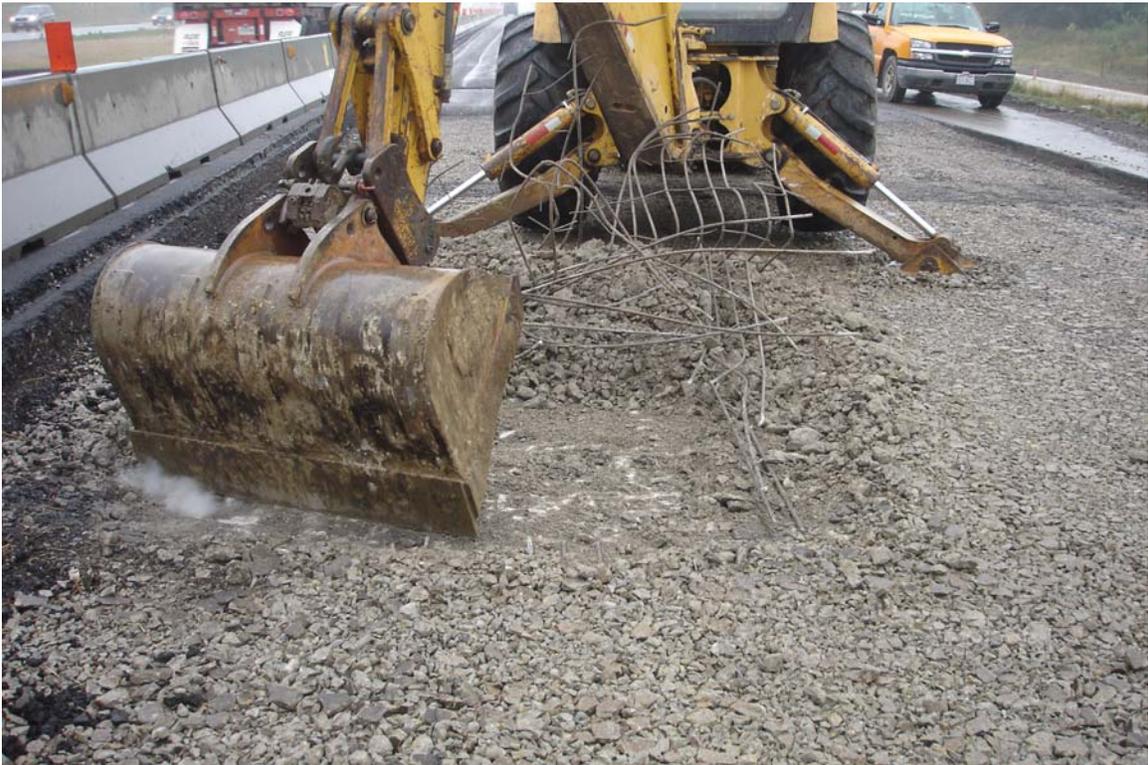
As it turned out, precisely determining the extent to which the reinforcing steel was debonded by the fracturing operation based on visual inspections of excavated concrete was a delicate task. In general, it appeared that on the I-71 project, the MHB achieved only mixed success in debonding. On the other hand, the rubbleizing operation on I-70 appeared to have consistently debonded the steel (Figure 35).

**Figure 35. Steel Debonding on I-70 Project**

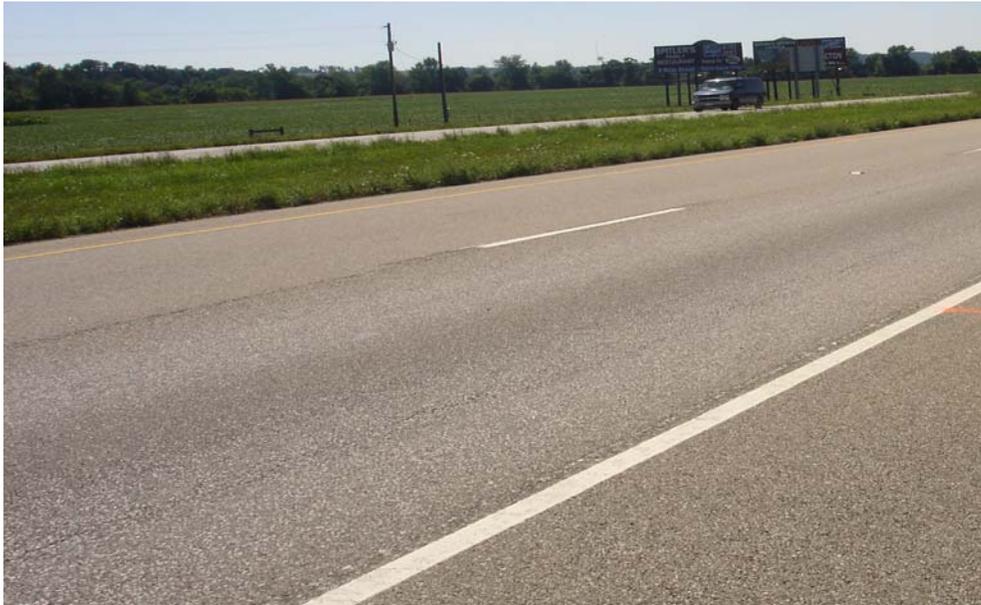
After 13 years of service, the rehabilitated COS-36 pavement has remained in generally good condition. The asphalt surface shows some raveling and slight longitudinal cracking resulting from a cold joint, with occasional reflection cracking (Figure 39).

**Figure 39. General Condition of COS-36 Pavement**

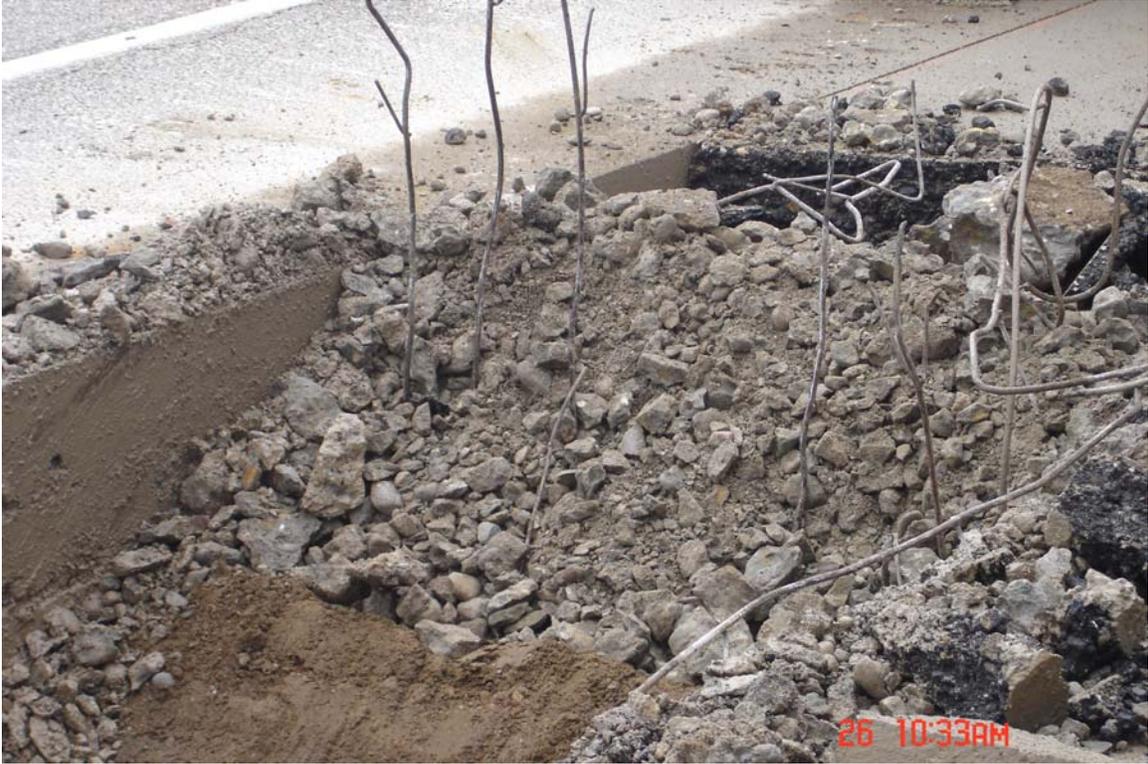
The RPB equipment was generally very effective in achieving debonding of the reinforcing steel (Figures 46-47). In many places, it appeared that the reinforcing mesh had been broken by the fracturing operation. Indeed, in one seemingly remarkable instance, a steel dowel recovered from the test pit evidently was also fractured.

**Figure 46. Debonding of Reinforced Steel on the COS-36 Project**

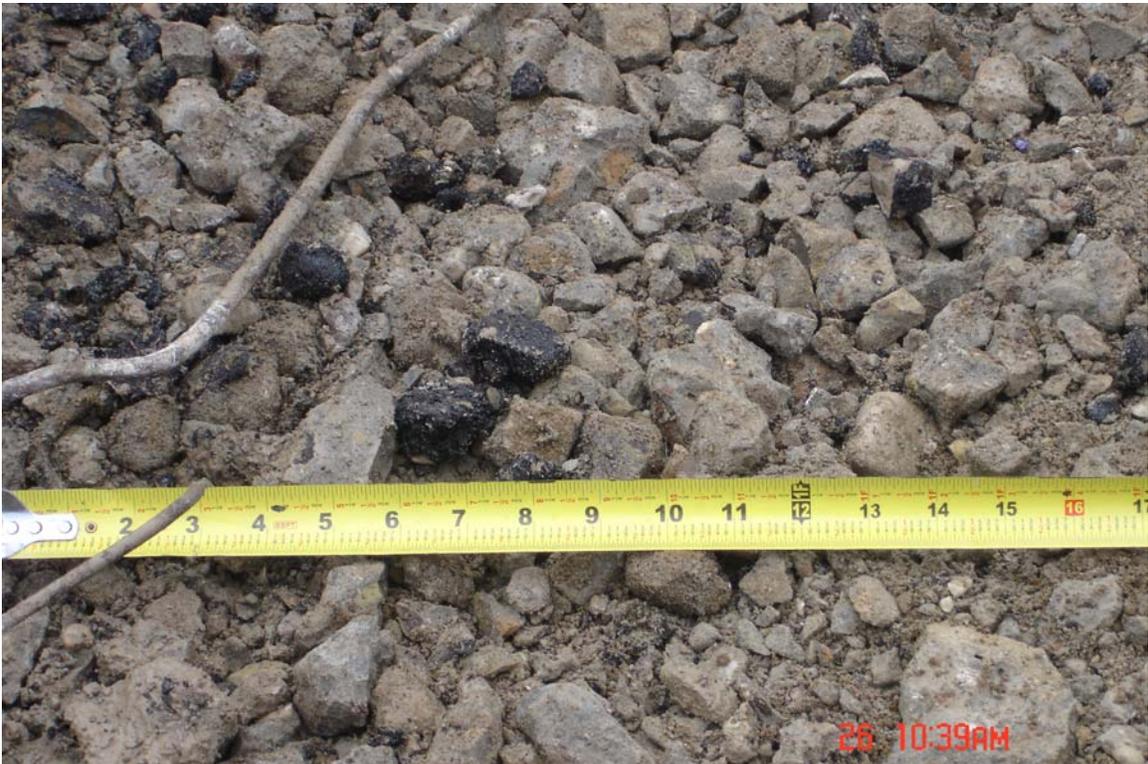
**Figure 47. Debonding of Reinforcing Steel on the COS-36 Project**
